HAMSTIR Series Improvement Information of RF Interference

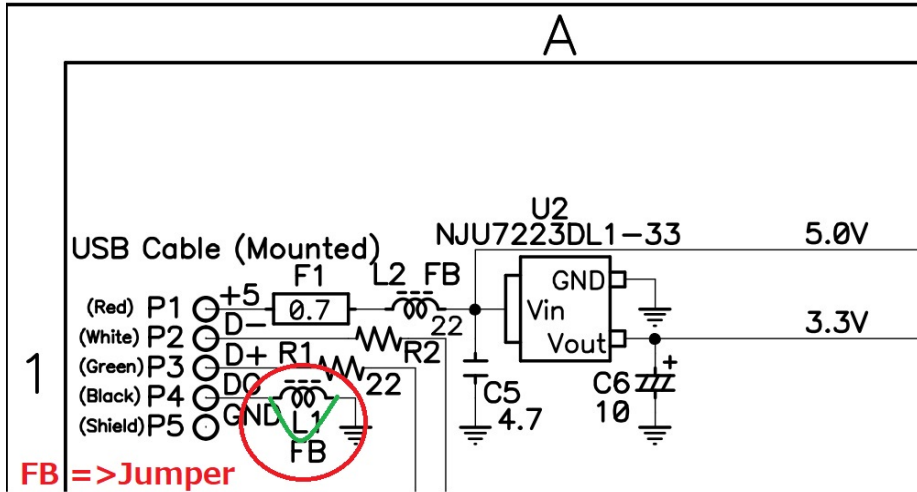
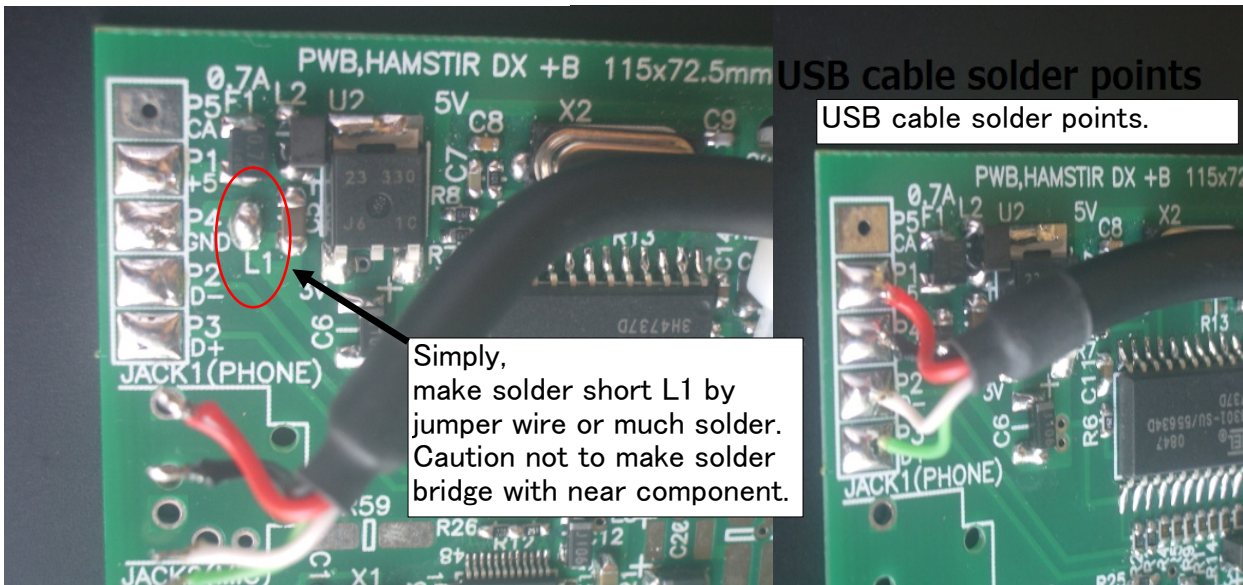
* Some malfunction may happen such as COM unstable or sound device lost.

Some PC made strong EMC/EMI countermeasure into it's USB circuits.

Also, HAMSTIR interface did similar countermeasure.

After that, both countermeasures made weak situation.

As this countermeasure is for receiving noise improvement of some other electrical products, for HAMSTIR basic functions, it's no affection.

At present, This was all applied into HAMSTIR DX andST by change of component from ferrite bead to jumper wire.
